Regency 24" x 60" 14-Gauge Stainless Steel Floor Trough with Grate

#600FT2460SS

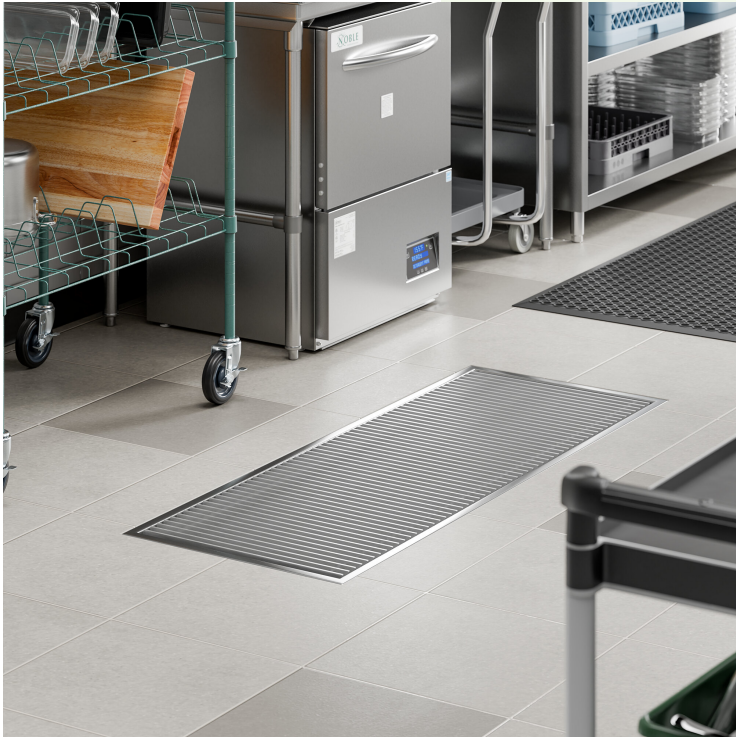
- Features a sturdy 14-gauge, type 304 stainless steel construction
- Comes with a 3" long, 4" diameter drain outlet
- Includes a removable strainer basket for optimal convenience
- Designed with a removable 3/16" x 1" subway-style grating
- Flanges mount directly to the subfloor for added stability

Maintain safe and sanitary floor conditions in your busy back-of-house area with this Regency 24" x 60" 14-gauge stainless steel floor trough with grate. Featuring a durable 14-gauge, type 304 stainless steel construction, this item was built for increased longevity and everyday use. Not only is it great for installation beneath steam equipment in your restaurant's kitchen, allowing for efficient end-of-day draining, but also it can be utilized within any establishment that requires draining of excessive amounts of water. Not to mention, the flanges around the perimeter mount directly to the subfloor to provide added stability.

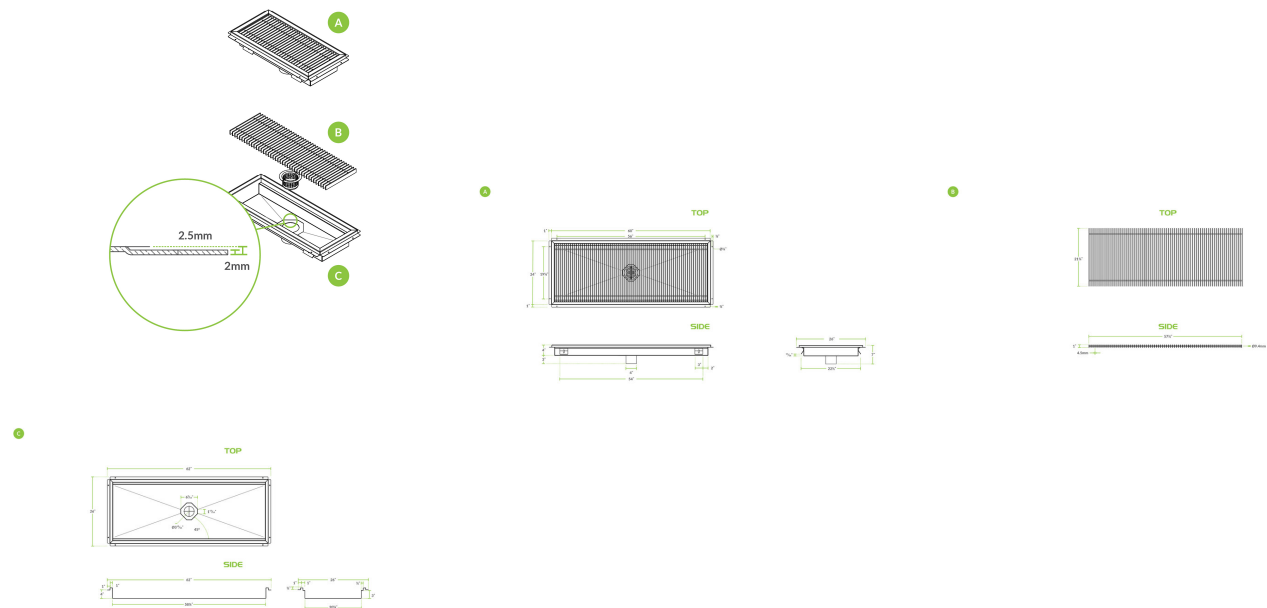
Plan View

This Regency floor trough comes with a removable 3/16" x 1" subway-style grating that boasts an even 9/16" spacing between each bar. This spacing permits fluids to easily flow through, and it blocks potential clogs while enabling equipment and casters to roll over the trough without getting stuck. Plus, this item was constructed with a convenient creased design to ensure proper draining into its 3" long drain outlet, which accommodates waste pipes up to 4" in diameter. It even includes a removable strainer basket for effortless cleaning!
