Regency 24" x 72" 14-Gauge Stainless Steel Floor Trough with Grate

#600FT2472SS

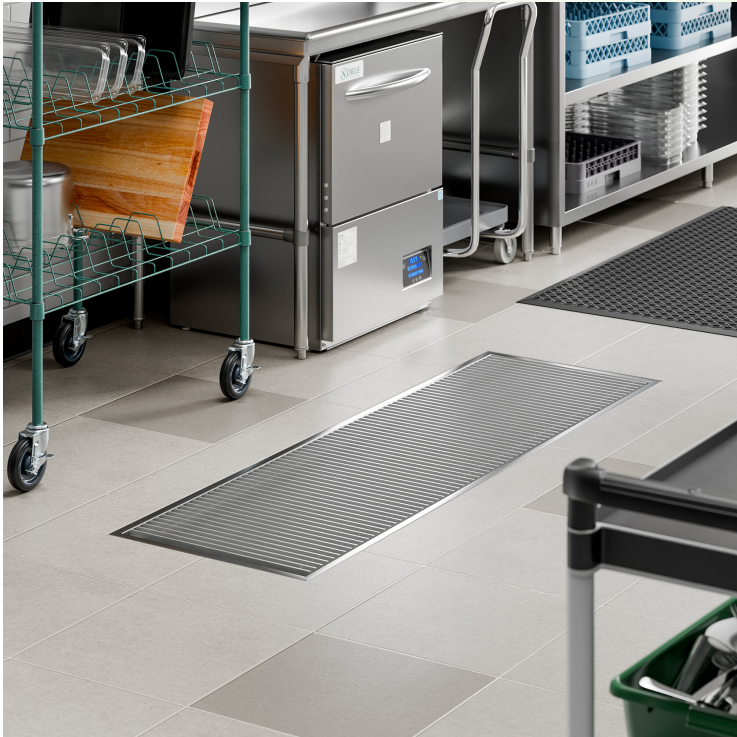
- Features a sturdy 14-gauge, type 304 stainless steel construction
- Comes with a 3" long, 4" diameter drain outlet
- Includes a removable strainer basket for optimal convenience
- Designed with a removable 3/16" x 1" subway-style grating
- Flanges mount directly to the subfloor for added stability

Maintain safe and sanitary floor conditions in your busy back-of-house area with this Regency 24" x 72" 14-gauge stainless steel floor trough with grate. Featuring a durable 14-gauge, type 304 stainless steel construction, this item was built for increased longevity and everyday use. Not only is it great for installation beneath steam equipment in your restaurant's kitchen, allowing for efficient end-of-day draining, but also it can be utilized within any establishment that requires draining of excessive amounts of water. Not to mention, the flanges around the perimeter mount directly to the subfloor to provide added stability.

This Regency floor trough comes with a removable 3/16" x 1" subway-style grating that boasts an even 9/16" spacing between each bar. This spacing permits fluids to easily flow through, and it blocks potential clogs while enabling equipment and casters to roll over the trough without getting stuck. Plus, this item was constructed with a convenient creased design to ensure proper draining into its 3" long drain outlet, which accommodates waste pipes up to 4" in diameter. It even includes a removable strainer basket for effortless cleaning!
