Regency 24" x 96" 14-Gauge Stainless Steel Floor Trough with Grate

#600FT2496SS

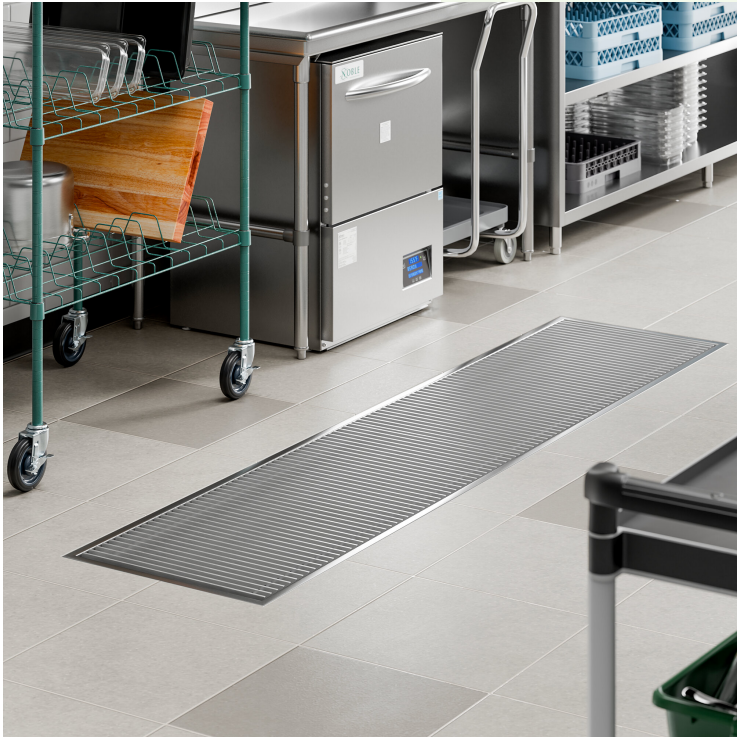
- Features a sturdy 14-gauge, type 304 stainless steel construction
- Comes with a 3" long, 4" diameter drain outlet
- Includes a removable strainer basket for optimal convenience
- Designed with a removable 3/16" x 1" subway-style grating
- Flanges mount directly to the subfloor for added stability

Maintain safe and sanitary floor conditions in your busy back-of-house area with this Regency 24" x 96" 14-gauge stainless steel floor trough with grate. Featuring a durable 14-gauge, type 304 stainless steel construction, this item was built for increased longevity and everyday use. Not only is it great for installation beneath steam equipment in your restaurant's kitchen, allowing for efficient end-of-day draining, but also it can be utilized within any establishment that requires draining of excessive amounts of water. Not to mention, the flanges around the perimeter mount directly to the subfloor to provide added stability.

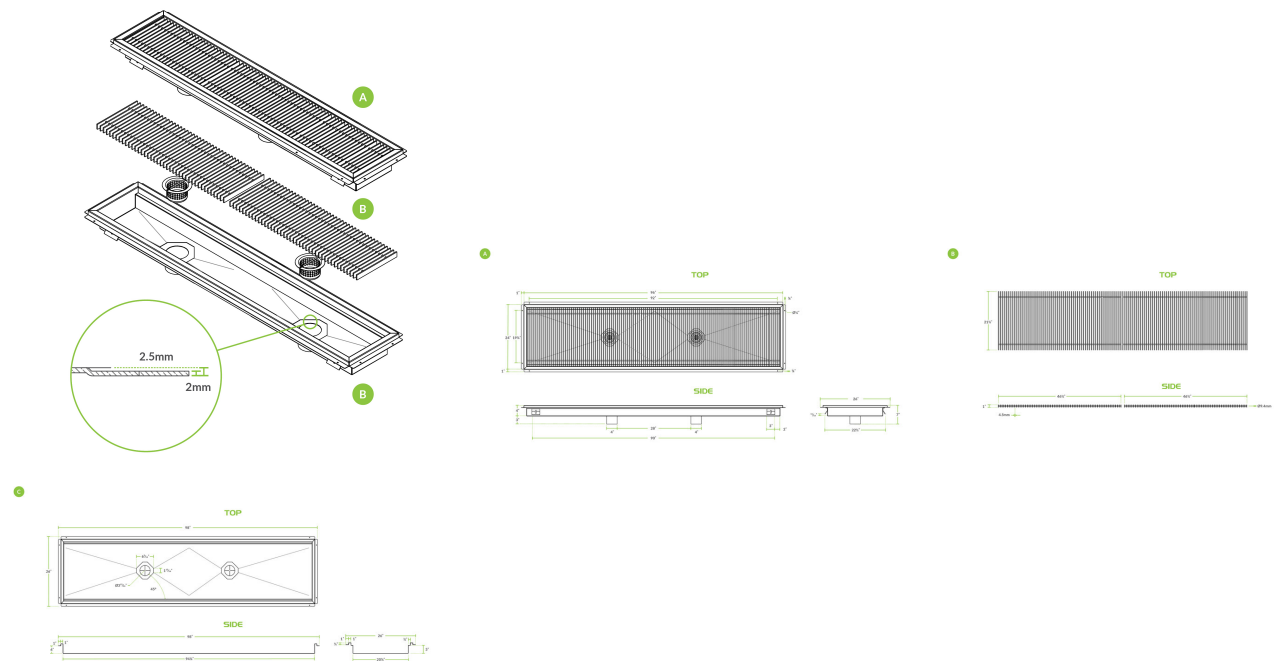
Plan View

This Regency floor trough comes with a removable 3/16" x 1" subway-style grating that boasts an even 9/16" spacing between each bar. This spacing permits fluids to easily flow through, and it blocks potential clogs while enabling equipment and casters to roll over the trough without getting stuck. Plus, this item was constructed with a convenient creased design to ensure proper draining into its 3" long drain outlet, which accommodates waste pipes up to 4" in diameter. It even includes a removable strainer basket for effortless cleaning!
