# FQE60U

# FilterQuick™ easyTouch® Electric Fryer

## Service Manual

Part Number: FRY\_SM\_8197626 06/2021

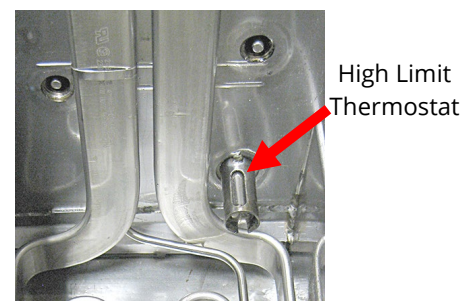
Figure 2

7. Insert the leads into the 12-pin connector C-6 (see Figure 3). The leads go into positions 1 and 2 of the connector, polarity does not matter.

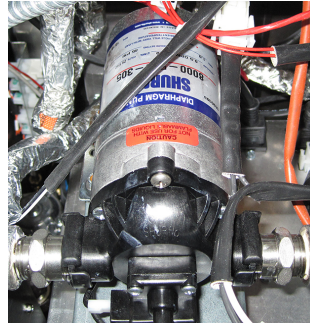
Figure 22

Disconnect the fryer from the electrical power supply. Locate the ATO pump (see Figure 22. Mark and unplug any wires or harnesses. Press down from the top on the quick disconnects to release the plumbing (see Figure 23). The plumbing can be pulled from the pump. Loosen the four nuts attaching the pump to the pump tray. Disconnect the electrical connection. Replace the defective component and reverse above steps. Once replaced, reconnect the power.

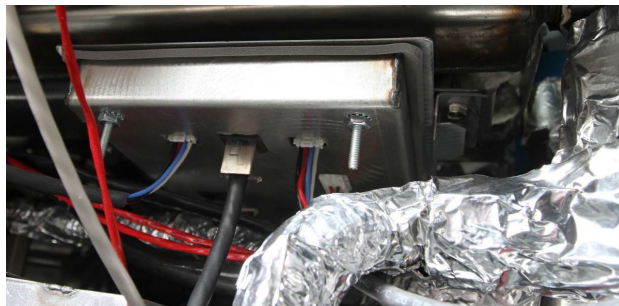
Figure 25

The VIB (Valve Interface Board) controls the actuators that open and close the drain and return valves. The VIB boards are located inside a protective housing under each frypot (see Figure 25).
