Regency 24" x 42" 14-Gauge Stainless Steel Floor Trough with Grate

#600FT2442SS

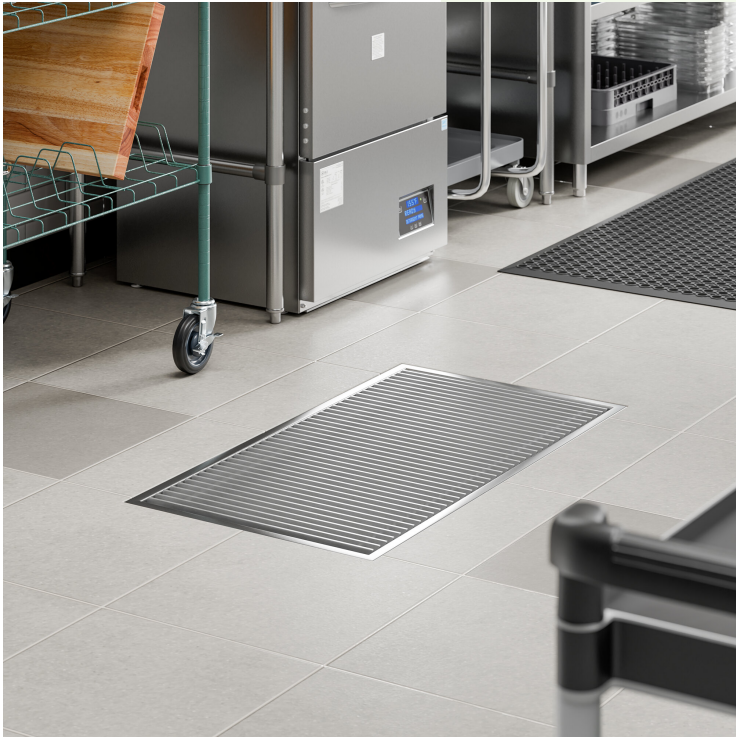
- Features a sturdy 14-gauge, type 304 stainless steel construction
- Comes with a 3" long, 4" diameter drain outlet
- Includes a removable strainer basket for optimal convenience
- Designed with a removable 3/16" x 1" subway-style grating
- Flanges mount directly to the subfloor for added stability

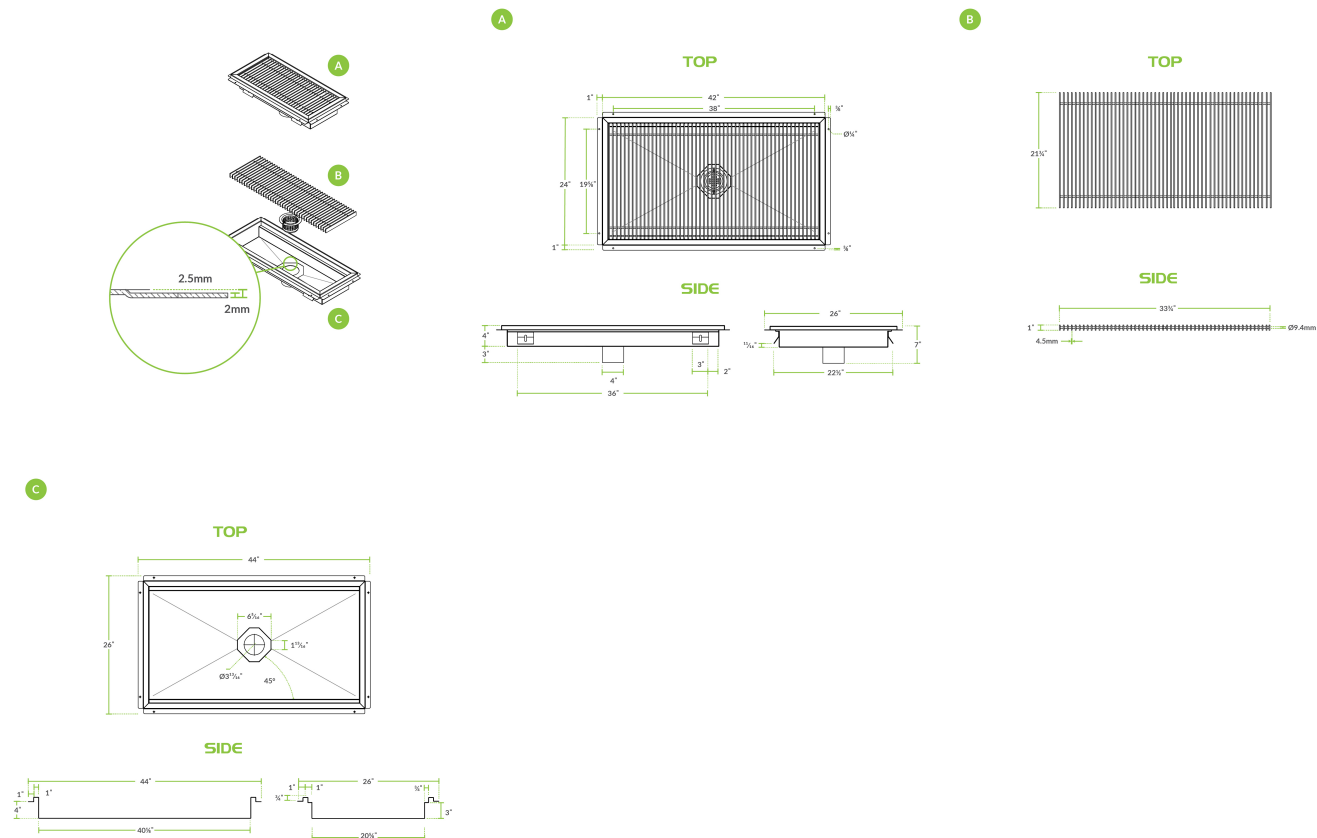
Plan View

This Regency floor trough comes with a removable 3/16" x 1" subway-style grating that boasts an even 9/16" spacing between each bar. This spacing permits fluids to easily flow through, and it blocks potential clogs while enabling equipment and casters to roll over the trough without getting stuck. Plus, this item was constructed with a convenient creased design to ensure proper draining into its 3" long drain outlet, which accommodates waste pipes up to 4" in diameter. It even includes a removable strainer basket for effortless cleaning!
